# ARKOS

**Arkos**  
quarterly  
Fifth series - n. 15-16  
July-December 2016  
ISBN 978-88-8393-129-1

# Summary

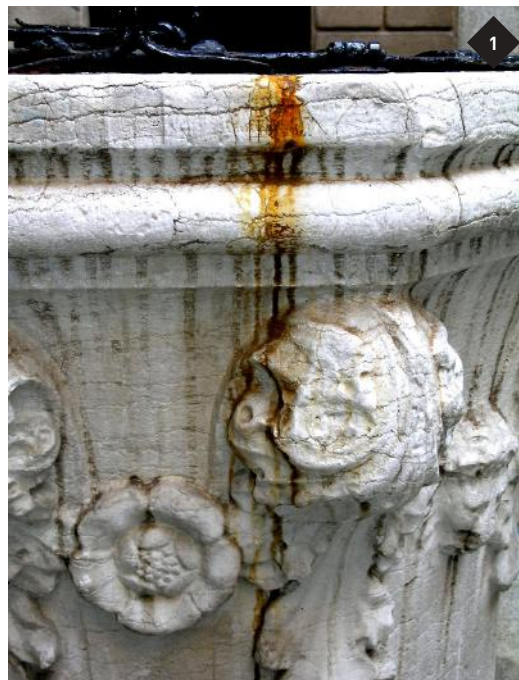
◆ **FIGURE 1**  
ACCIDENTAL RUST STAIN ON A WELL-CURB MADE OF WHITE LIMESTONE ("PIETRA D'ISTRIA", VENICE).

The presence of iron on stone surfaces has two different origins: the first is fortuitous and it is related to metal works always used in a building (**Fig.1**), the second is substantial and it is related to iron minerals naturally occurring in some stones used for building (**Fig.2**).
